1. AGENCY USE ONLY (Leave blank)		2. REPORT DATE September 1996		3. REPORT TYPE AND DATES COVERED Final, April 1994 - September 1995
4. TITLE AND SUBTITLE Failure Analysis and Mechanical Tests of Failed Aluminum Alloy 7277 Rivets on Armored Vehicle Launched Bridges			5. FUNDING NUMBERS PR: 1L162618AH80

6. AUTHOR(S) Howard E. Horner				
7. PERFORMING ORGANIZATION NAME(S) AND ADDRESS(ES) U.S. Army Research Laboratory ATTN: AMSRL-WM-MA Fort Belvoir, VA 22060-5812			8. PERFORMING ORGANIZATION REPORT NUMBER ARL-TR-1195

13. ABSTRACT (Maximum 200 words) A number of the manufactured buttonheads of the 0.75-in-diameter hot-driven aluminum rivets (made of alloy 7277) were found to have fallen off Class 60 Armored Vehicle Launched Bridges (AVLB) that had been employed in Saudi Arabia during Operation Desert Storm. The presence of white corrosion deposits observed on the fractured surfaces of the failed heads indicated corrosion. The objectives of the work were to determine the cause of rivet head failures and conduct a number of mechanical tests to evaluate the integrity of the corroded rivets without their heads or with cracked heads. Corroded aluminum rivet samples were obtained, examined

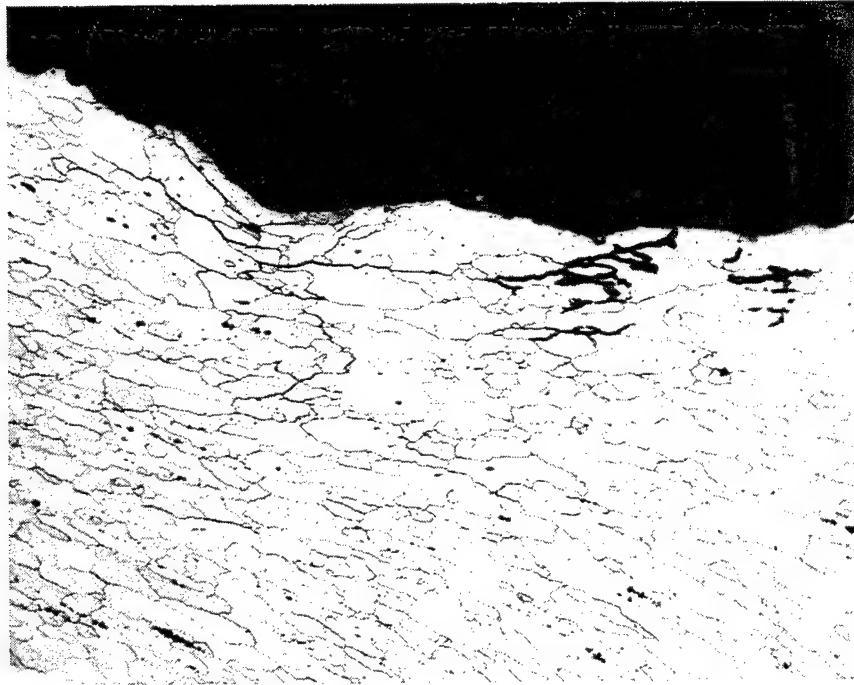
Figure 10. Etched microstructure of the same area in Figure 9. Magnification: 170x. Keller's etchant.

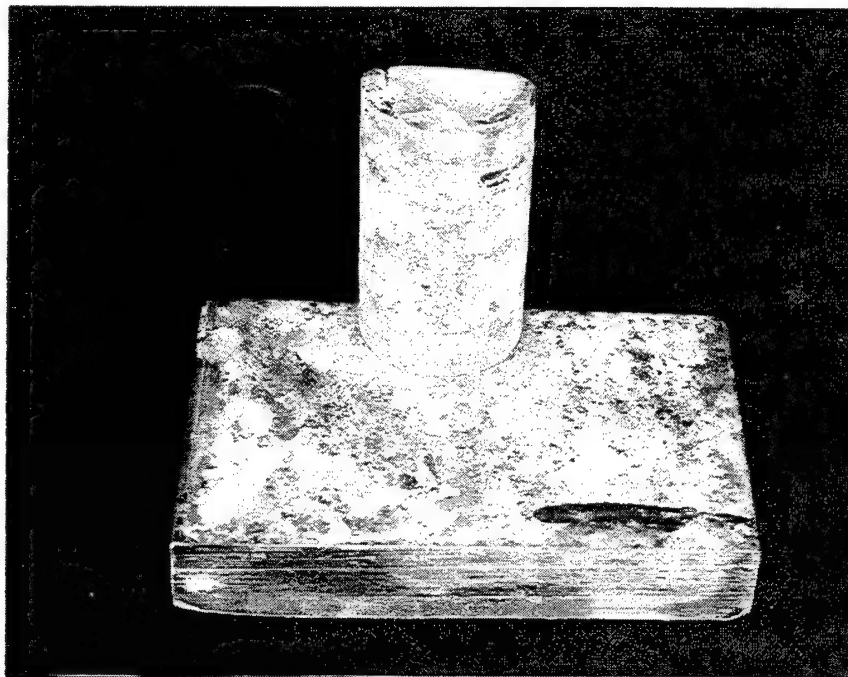
Figure 14. A section of the aluminum rivet shank still in the rivet hole of the spacer bar removed from the AVL B center panel assembly dismantled at ANAD. The bare surfaces of the rivet and bar were heavily covered with the white corrosion products. This sample was already cut in two for metallurgical examination. Magnification: approximately 1.25x.

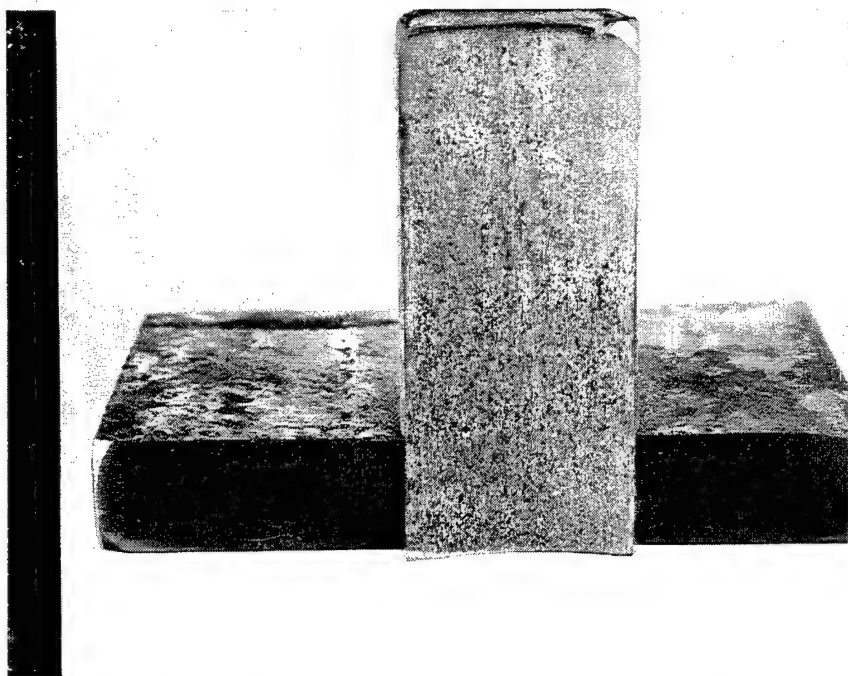
Figure 15. Etched cross section of the sample in Figure 14 to show end of the rivet shank still in the rivet hole of the spacer bar. Magnification: approximately 1.6x. Keller's etchant.

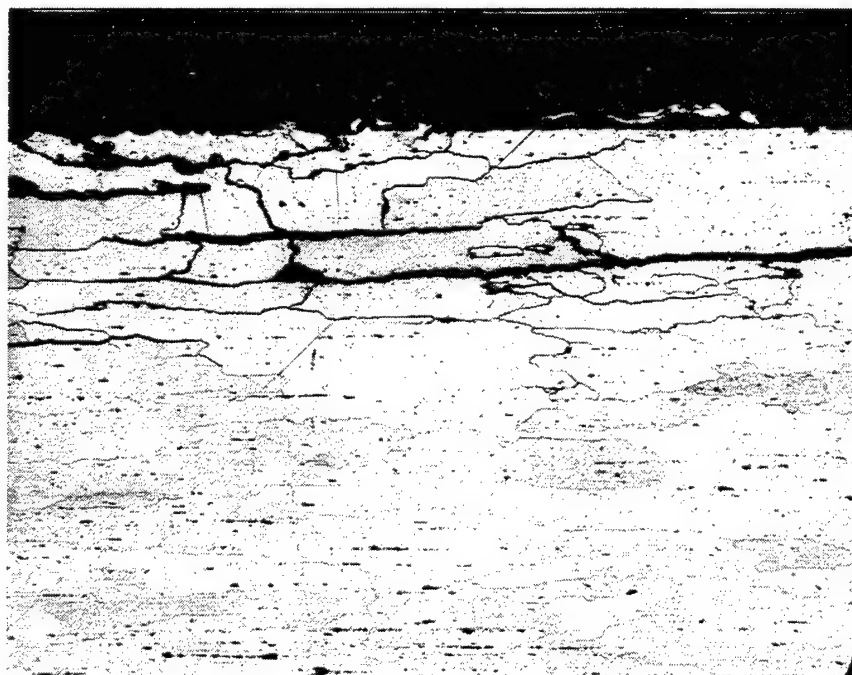
Figure 19. Etched microstructure of the same area in Figure 8. Magnification: 100 \times . Keller's etchant.

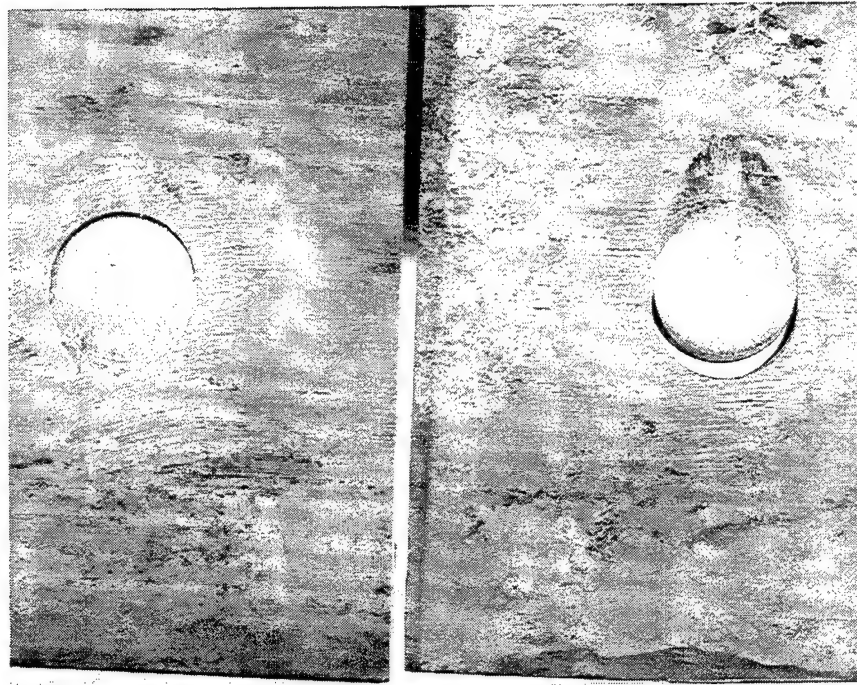
When the load-deflection curves were reviewed, each curve began to deviate from the straight line at about 30,000 lb. This would indicate permanent deformation of the test specimen, primarily in the rivet hole of the girder plate plunger and in the shank of the rivet (see Figure 25).

Figure 25. View of the rivet holes in the angle vertical leg on left and in the girder plate plunger on right after the shear test. Elongation of the rivet hole in the plate plunger was greater than the hole in the angle leg as noted by the gap. Sheared sections of the rivet shank remained in the holes. Actual size.

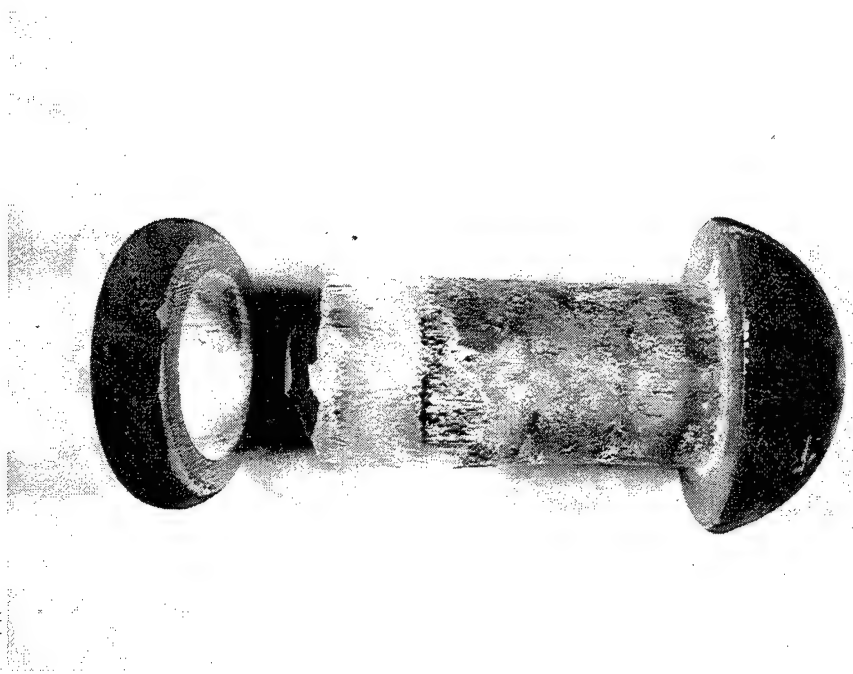
Figure 30. A view of the rivet (specimen D) with the sheared driven end (left) after the pull test.

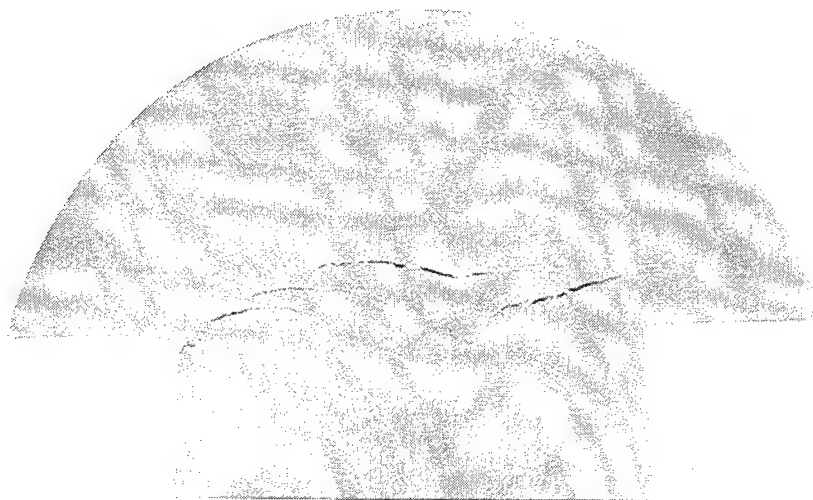
Figure 32. A view of the rivet that was rough cut in half lengthwise in the top connector of the AVL B, thus revealing large cracks in the head. The crack initiated in the fillet. See Figure 33 for polished surface of the same rivet.

Figure 33. Same rivet in Figure 32, except with as-polished surface of the cut areas.

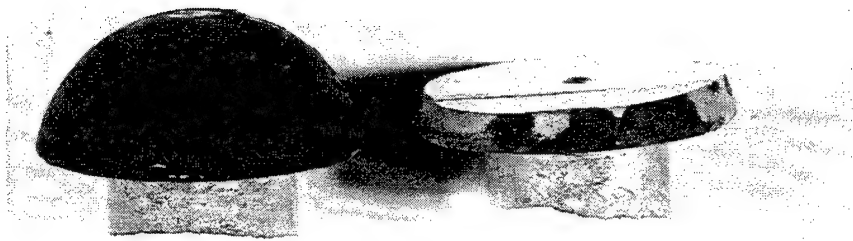
Figure 34. A view of two rivet heads (specimen B on left and specimen D on right) after the shear tests.
A portion of specimen D rivet head was inadvertently cut off during the specimen preparation prior to the pull and shear tests.

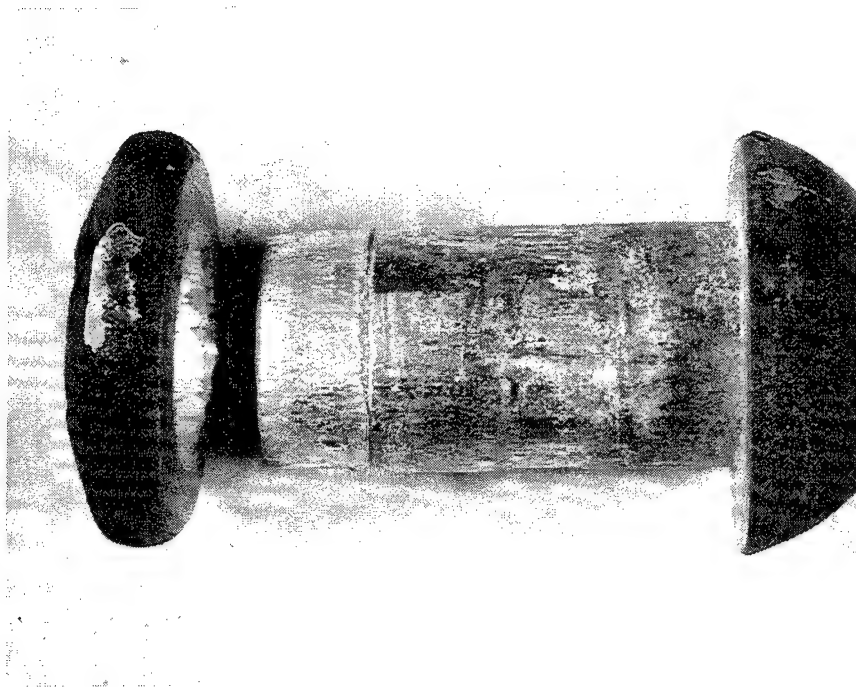
Figure 35. Enlarged view of specimen A "Good" rivet which sheared at its driven end through the rivet hole of the angle leg during the pull test. Magnification: approximately 2x.

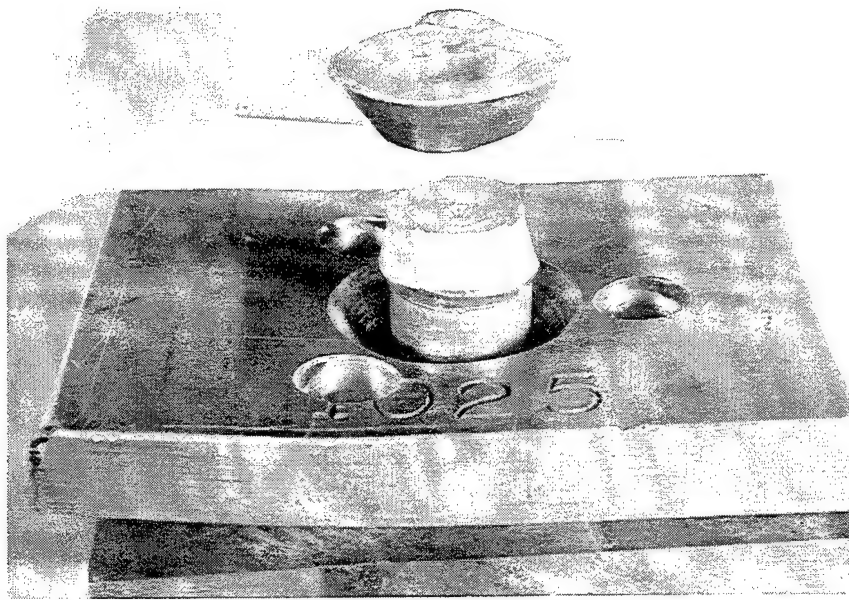
Figure 39. An example of the shearing at the flat countersunk head of unpainted 1,025° F rivet sample.

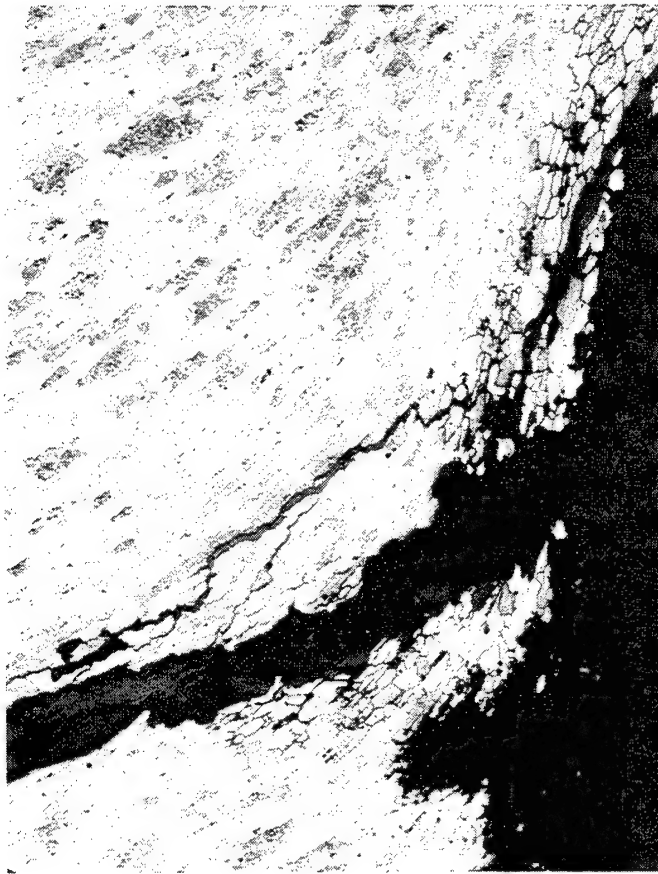
Figure 45. Etched microstructure of the same area in Figure 44, showing the grain flow formed by the head-forming operation. Magnification: 100x. Keller's etchant.

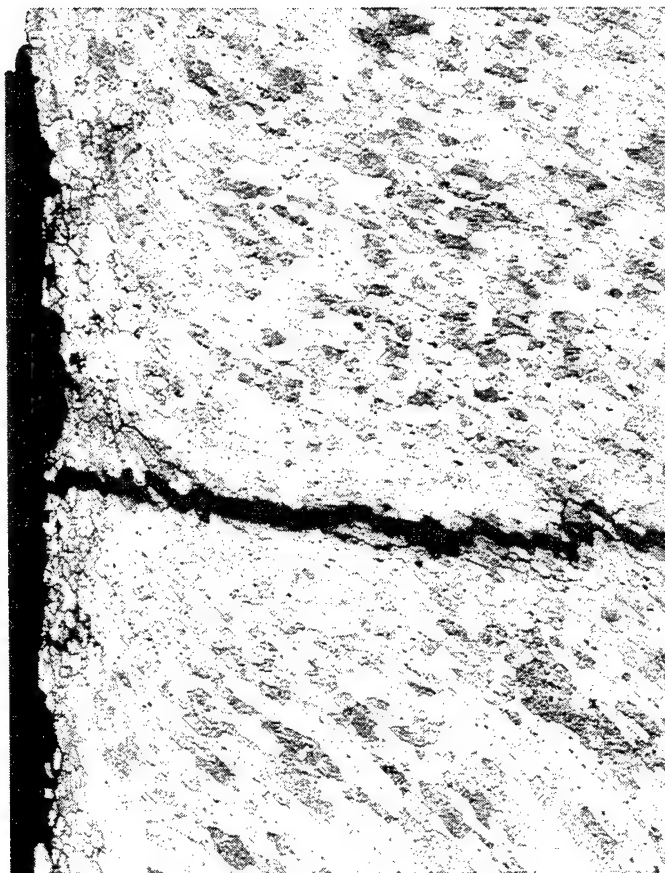
Figure 47. Etched microstructure of the same area in Figure 46, showing the grain flow formed by the head-forming operation. Magnification: 100 \times . Keller's etchant.

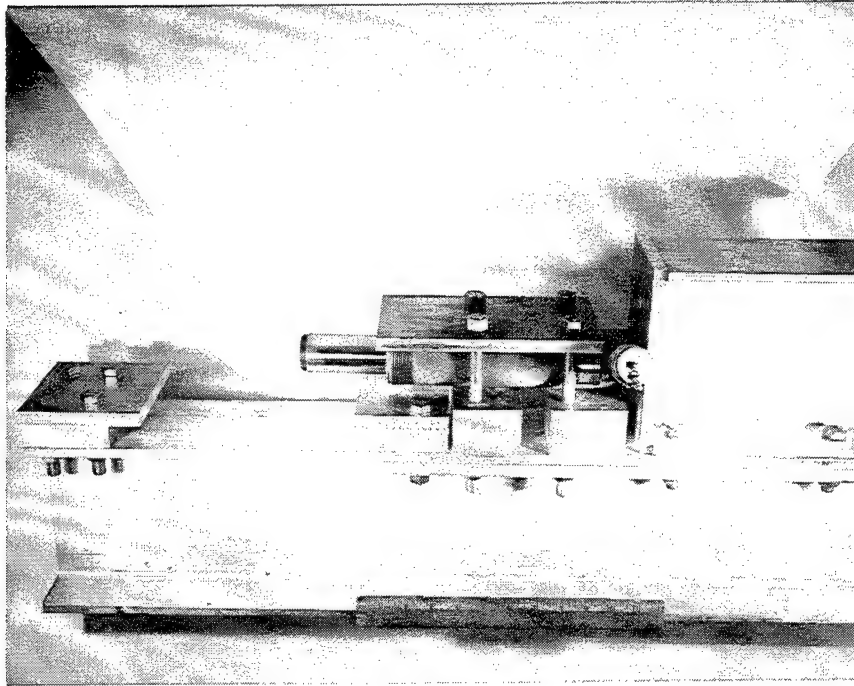
The special load jig (see Figure 48) for the tests was designed and fabricated so that it can be clamped to the horizontal legs of the aluminum chord angles and forged connectors on the bottom or top chord of the AVLB center or end panel assembly. It had a hydraulic cylinder with a hand pump and load dial. The jig was clamped to the bridge top chord and connector by bolts and plates in line with the headless rivet to be pushed out (see Figure 49). A 0.5-in-diameter steel bar 2 in long with two strain gauges on

Figure 48. A view of the special push load jig after the fabrication. A small hydraulic cylinder is clamped to the aluminum I-beam with aluminum plate and blocks and steel bolts. It is butted against the upper I-beam, serving as a backstop.

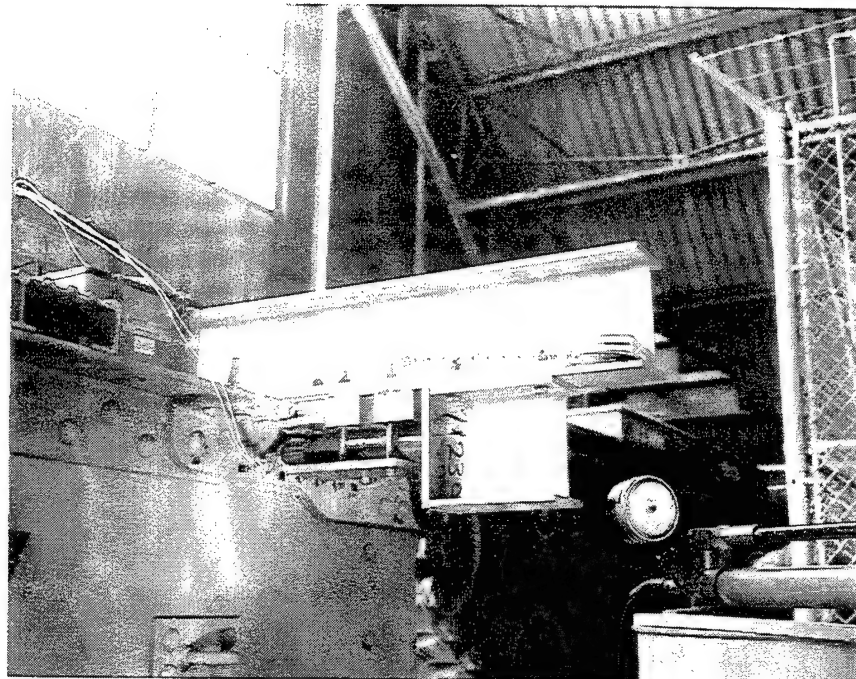
Figure 49. Overall view of the special load jig clamped to the top outboard male connector of the AVLB female center panel assembly by means of bolts and plates. The hydraulic cylinder and its hand pump are seen in this photograph. Three extruded aluminum deck panels had to be removed from the top of panel assembly in order to perform the test.

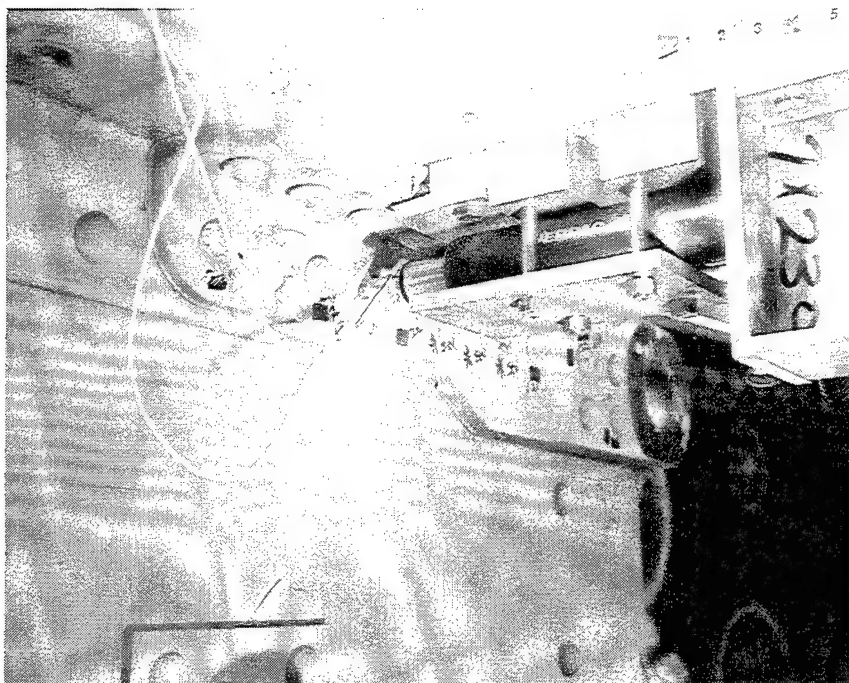
opposite sides was placed between the headless end of the rivet and the plunger of the hydraulic cylinder (see Figure 50). The strain gauges on the pin indicated the loads applied to the rivet being pushed out. The pin was calibrated so that the strain readouts on the strain indicator can be read as pounds instead of microinches. Another steel pin with two strain gauges was used as the compensating component ("dummy") in the strain indicator instrumentation setup. The maximum load required to break the rivet loose in its holes was recorded during the test.

Figure 50. Closeup view of the special jig in Figure 49, showing the placement of the 0.5-in-diameter steel pin (with two strain gauges) between the headless end of the rivet and the plunger end of the hydraulic cylinder. This jig was setup for the testing of the no. 4 rivet. The cables from the strain gauges were connected to the strain indicator not seen in this photograph.

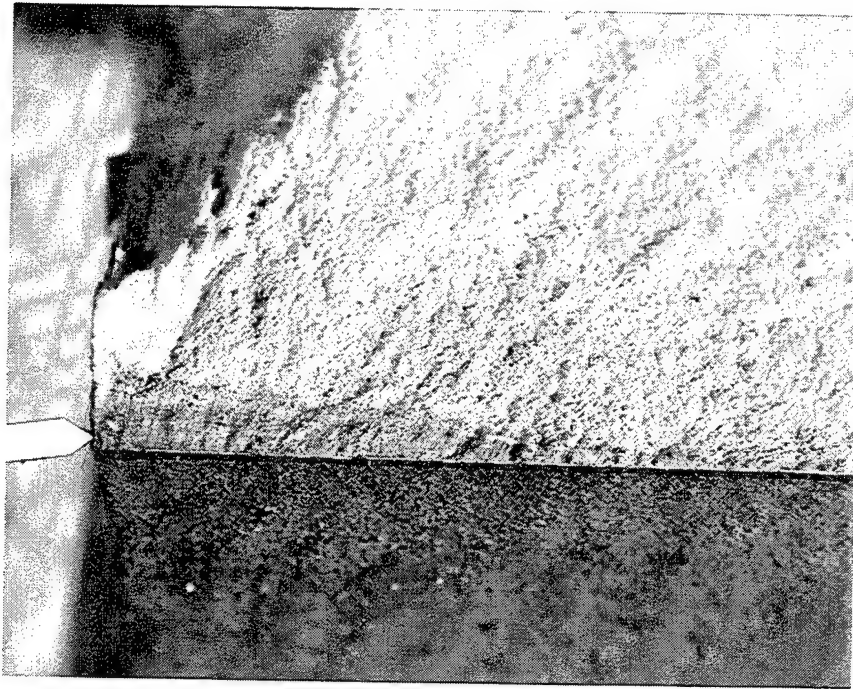
outboard male connector broke at the sharp fillets machined on the sides of the connector forgings (see Figure 53). The eyes of the inboard male connector broke in half through the hole seen in Figure 54. Visual examination was made on the fractured surfaces of the major failed components. Figures 55 and 56 reveal that the initiation sites of the brittle fractures of the outer female center hinge had occurred at a small fatigue crack at the surface of the eyehole. Figures 57 and 58 reveal the small fatigue cracks initiated at the sharp machined fillets that led to the brittle failure of the outboard male connector eyes. Figure 59 shows small fatigue cracks at the surface of the eyehole of the inboard male connector. The samples containing the crack in the bottom chord angles found during the visual inspection before the overload test were cut out in order to view the fractured surfaces (see Figure 60). Again, small fatigue cracks were observed initiating at the bottom of the countersunk rivet hole of one sample (see Figure 61). Figure 62 shows the extent of corrosion on the underlying surfaces next to the aluminum connector forging.

Figure 57. Closeup view of a small fatigue crack (arrow) at A in Figure 53 where it was initiated at the sharp machined fillets (straight edge).

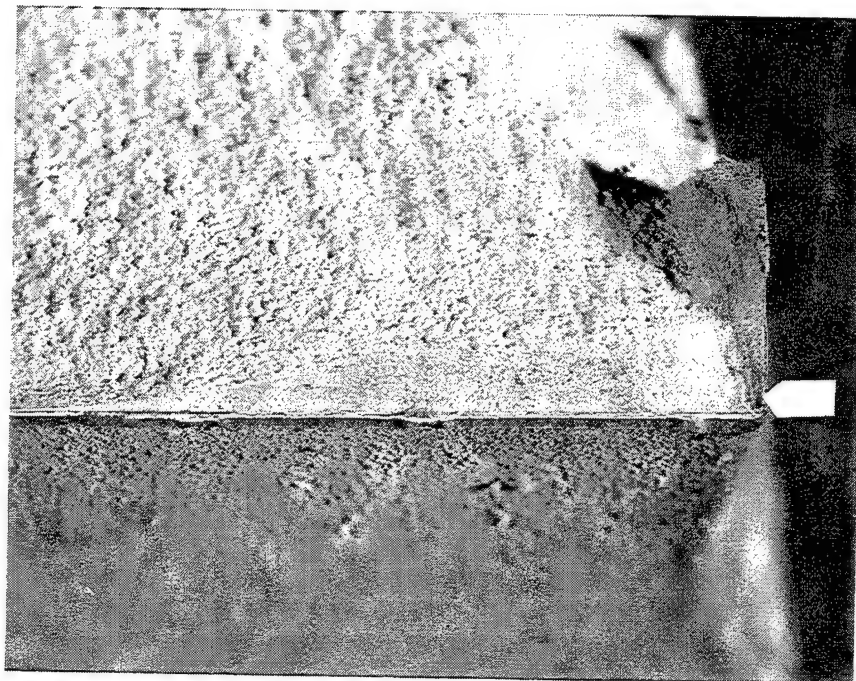
Figure 58. Closeup view of a small fatigue crack (arrow) at B in Figure 53 where it was initiated at the sharp machined fillet (straight edge).

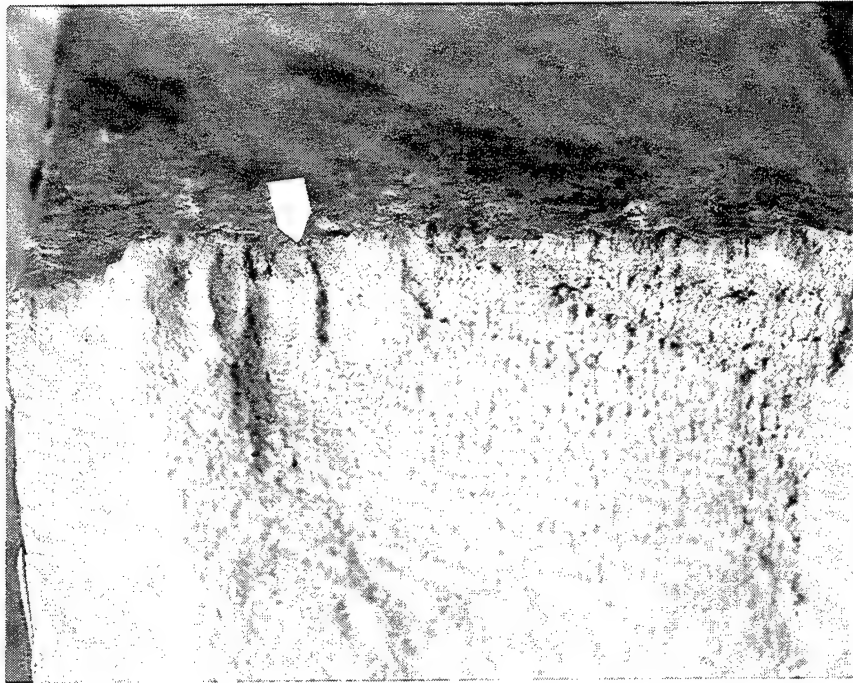
Figure 59. Closeup view of the fracture at A in Figure 54 showing small fatigue cracks (top edge) in the eyehole where the brittle fracture initiated in the connector.

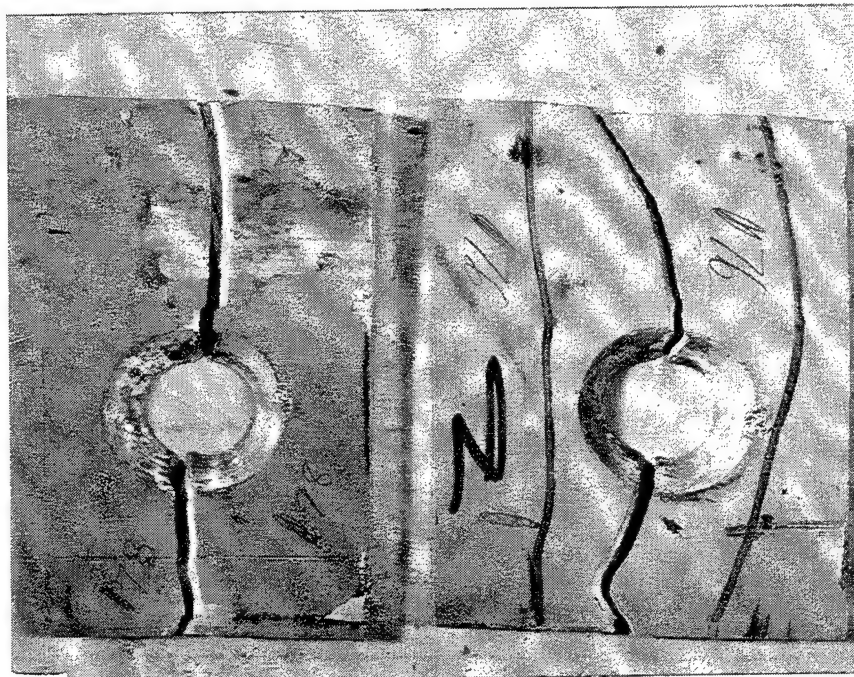
2.14 Metallurgical Examination of the Fractures of Several Failed Major Aluminum Components of Corroded AVL Bridge After the Overload Test. After a series of fatigue tests to simulate 3,000 crossings was performed on the corroded AVLB (from Fort Stewart) under the load frame at the Belvoir Center Bridge Hangar, a visual inspection of this bridge for new cracks was performed before the static overload test to failure. A major crack was found on the inner aluminum angle of the inboard bottom chord at the first rivet hole in the forged aluminum center hinge of two male center panel assemblies S/N 176 and S/N 178 (Contract DAAE07-86-C-2797). It was speculated that a catastrophic failure of the bridge may occur at one of those two cracks in the bottom chord angles during the overload test. A series of major component failures occurred on the bridge as the static loads increased during the test, but the final catastrophic failures did not occur in either crack located in the cracked bottom chord angles.

Figure 60. Prior cracks at first countersunk hole of the inner outboard bottom chord angles of the male center panel assemblies that had occurred during the fatigue test of 3,000 simulated MLC-70 tons crossings. See Figure 62 on the extent of corrosion on the surfaces of the other side.

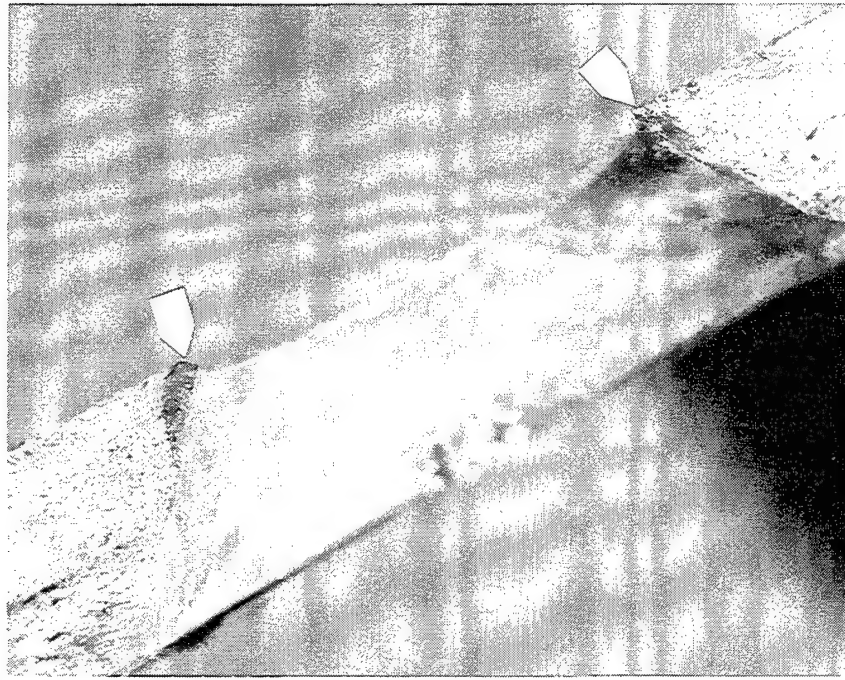
Figure 61. Closeup view of the fracture at the rivet hole of S/N 176 cracked angle leg in Figure 60, showing small cracks at upper corners of the hole. Corrosion may be the initiation sites for the cracks.

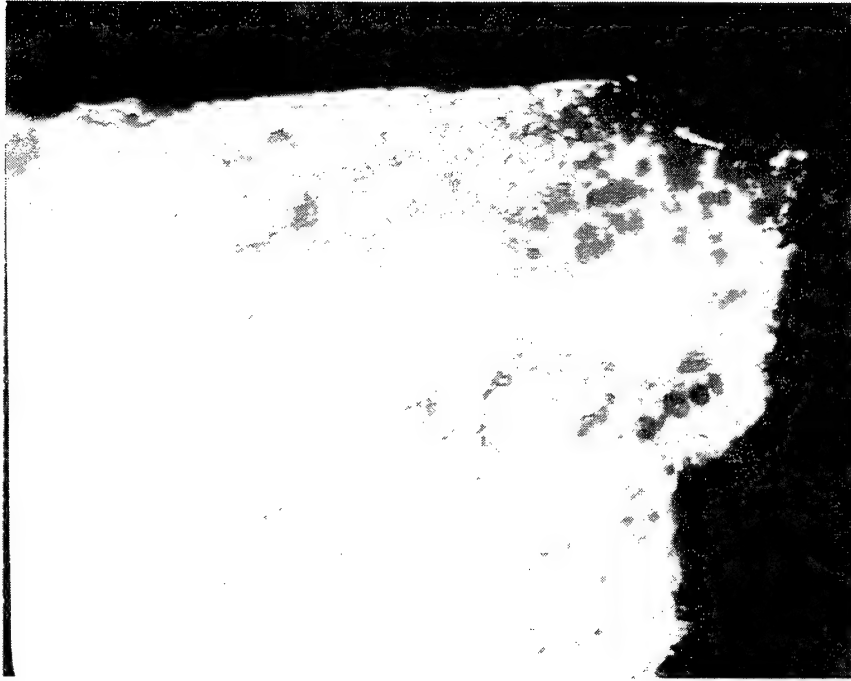
Small metallographic specimens for microstructural examination were cut from the fractured surfaces of the selected major bridge components in the areas where the cracks initiated. Figure 63 reveals the extensive network of intergranular corrosion at the initiation site of the fatigue crack at point A in Figure 52, the broken inboard female center hinge eye. Figures 64 and 65 show some intergranular corrosion on the corroded surfaces of both bottom chord angle samples in Figure 60 near the crack initiation sites of the fractures in the rivet holes.

Figure 63. Microstructure of the fracture at A of the broken inboard female center hinge eye in Figure 1.

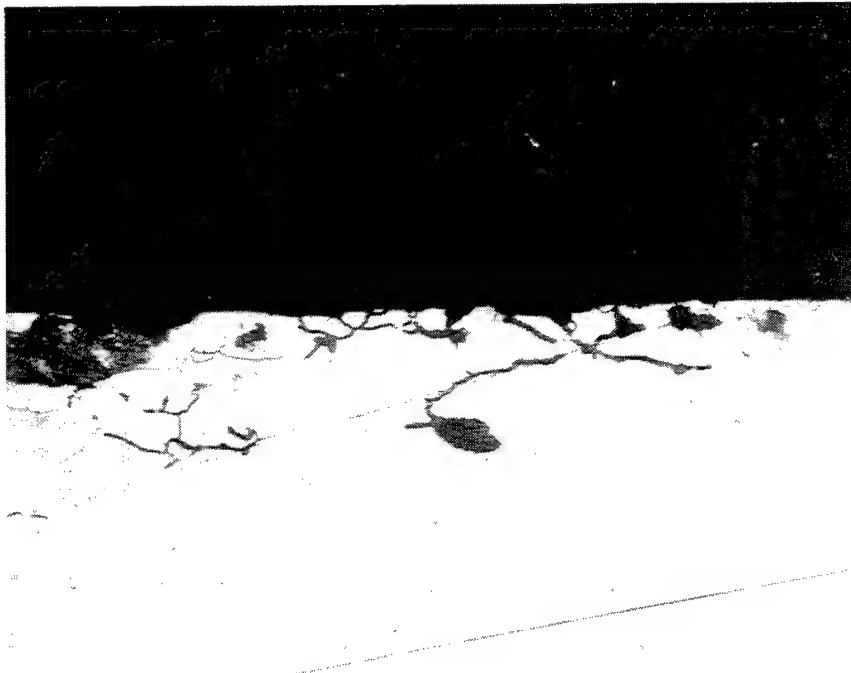
Figure 64. Microstructure of the corroded surface (top edge) near the fracture of the cracked bottom chord angle from male center panel assembly S/N 176 in Figure 62. Note the intergranular corrosion on the surface. Magnification: 160x. As-polished.

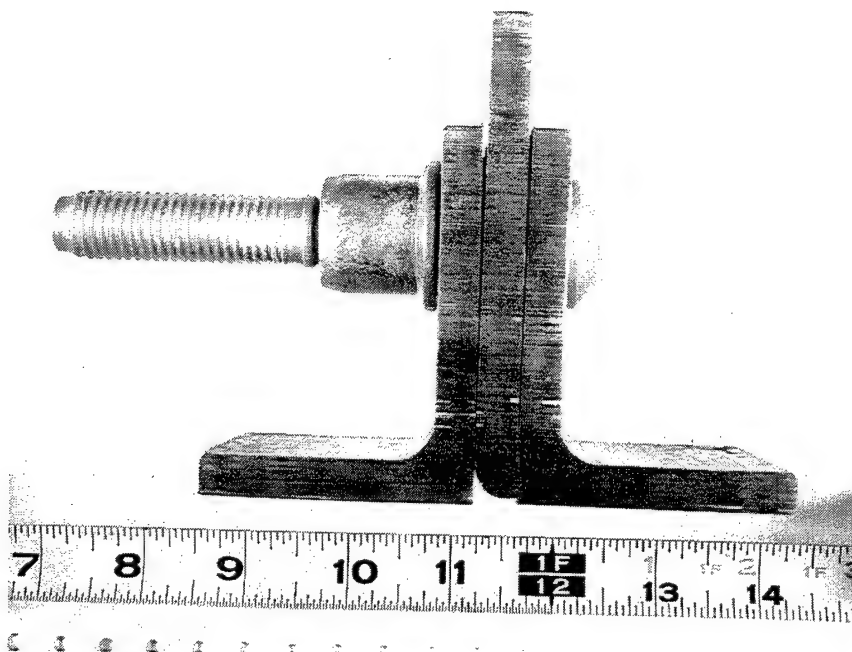
Figure 67. A view of the Huckbolt fastener in the rivet holes of the aluminum parts prior to swaging of the collar. The grip installation stem will be grabbed by the installation tool and broken off after the collar is swaged by the anvil of the tool.

When the supply of new rivets is gone, ANAD will use another type of fasteners that does away with hot driving as was done on aluminum alloy 7277 rivets. The new fastener is called a Huckbolt fastener (see Figure 66), consisting of an aluminum pin with the locking grooves and installation stem and an aluminum collar. "Huckbolt" is a registered trademark of the Huck International, Inc. With the use of the installation tool, the collar is swaged onto the locking grooves of the pin, and the stem is broken off like a familiar "pop" rivet (see Figures 67 and 68).

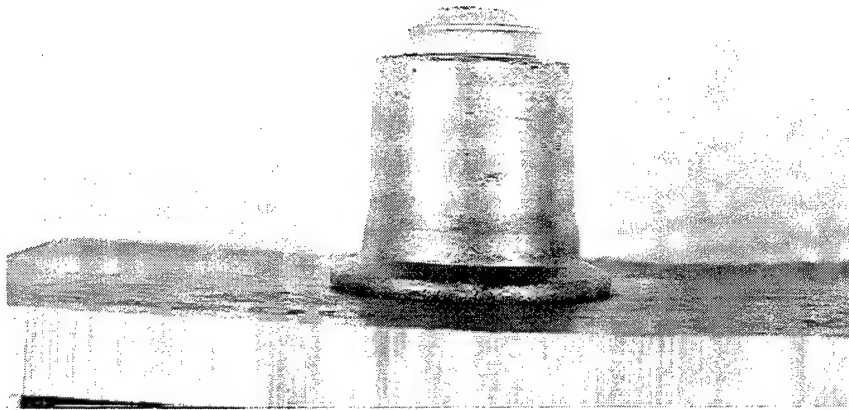
Figure 68. Closeup view of the fully swaged collar of the Huckbolt fastener after the installation. The grip stem of the pin was already broken off.
